**CITY COUNCIL STUDY SESSION
DURANGO CITY HALL, SMITH CHAMBERS**

DISCUSSION REGARDING
THE PRIORITIZED
2024 DEPARTMENT
CAPITAL PROJECTS
BUDGET

PARKS & RECREATION FACILITY INVENTORY AND FUTURE NEEDS ASSESSMENT

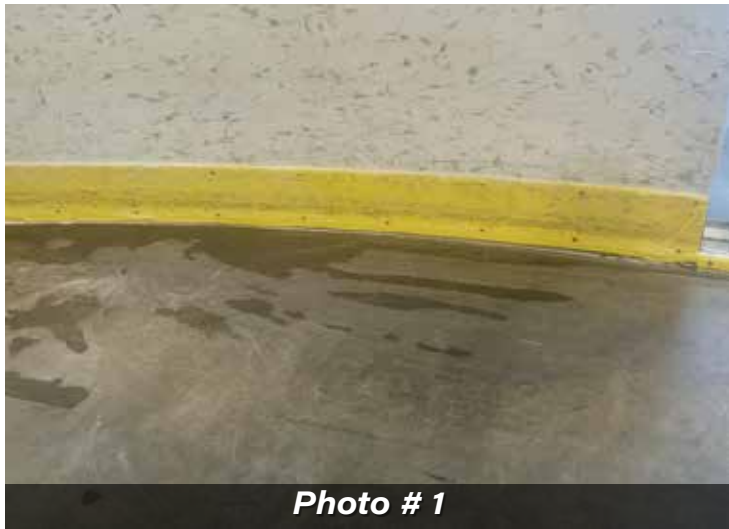
Photo # 1

- *It is widely known that this facility is built above an active underground spring, which causes ongoing issues with the soils there. These unstable soils may be the cause of the lower rink slab surface on the east side (See photo 1). It is recommended that a team of professionals be assembled to assess the long term outlook of the facility. The team should examine current soils condition, rink slab condition, ice plant longevity, steel structure condition and the ice pit.*

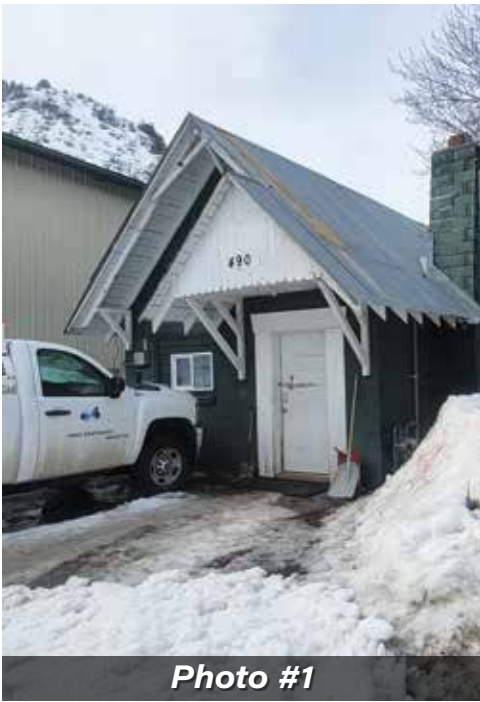
Photo #1

Replacement of the major components has been difficult. The steep grade of the hill provides challenges for the equipment needed to install the new lights and the lift supports. Additionally, staff has been unable to secure contractor(s) to supply the desired lift equipment. The current snow cat groomer is 20 years old and requires frequent maintenance. Parking is shared with the ice rink and typically unable to accommodate the number of users.

- The majority of amenities evaluated at the ski hill rate at either poor or very poor. It is however anticipated to rectify these conditions through upcoming capital improvement projects. The remaining items should continue as part of the ongoing CIP replacement programs identified by staff.

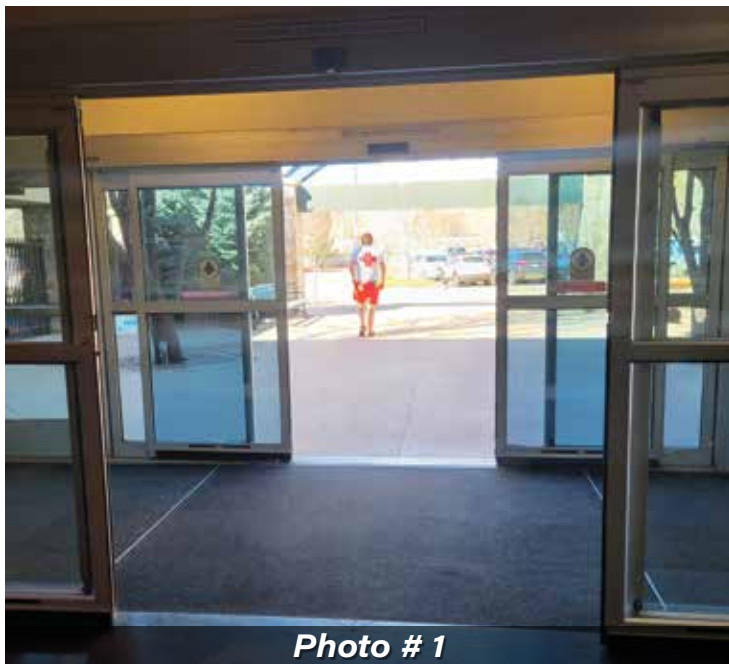
Photo # 1

- Consider a refurbishment of the water slide through a company such as Splashtacular, or Waterslide Restoration.
- The main entrance into the facility can be re-configured to address issues with cold weather and wind. Consider replacing double sliding doors with another system such as revolving doors or double pull doors with ADA access controls (see photo 1). This may also be an opportunity to renovate the main entry area including the front lobby, control desk and entry doors, allowing for a much brighter, open feel to the center as customers arrive.

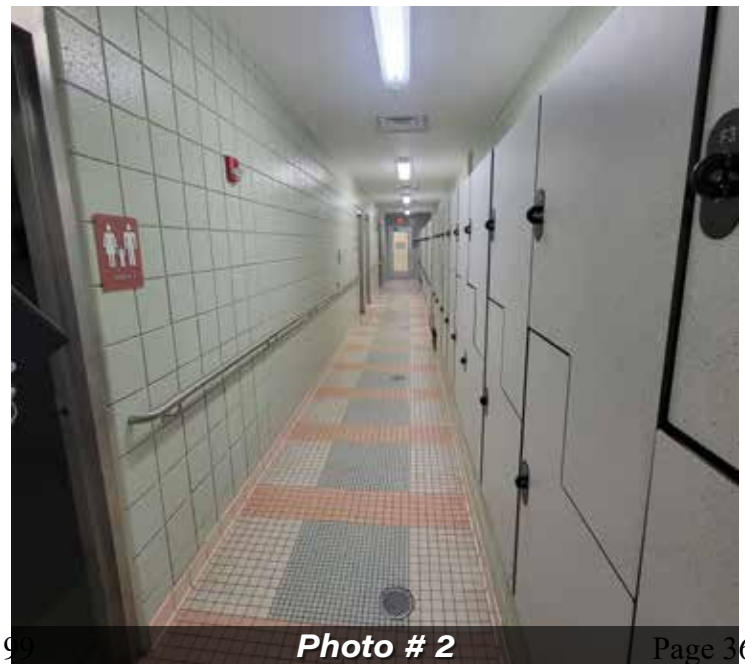
Photo # 2

- While the center is in exceptional condition, several areas appear to be outdated and in need of renovations. Locker rooms and restrooms are very high visibility areas, and updated colors, flooring and fixtures will be greatly appreciated by the facility users (see photo 2).

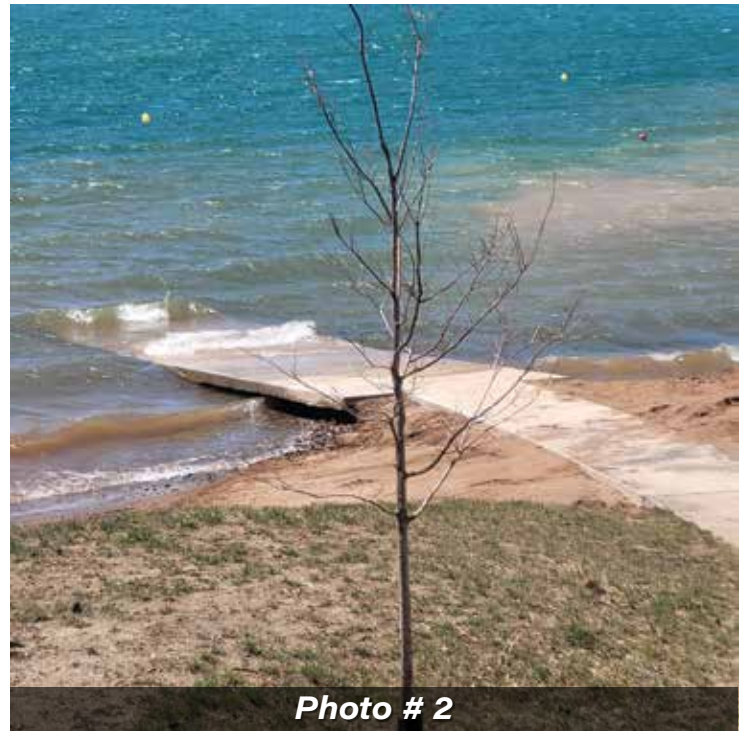
Photo # 2

- *Staff has implemented various options for controlling the erosion of the beach area including an annual build up of sand, and the installation of wave break material (buoyed barrels). These have resulted in minimal success. It is unclear if additional wave break material will have an increased effect. The sand option is currently the most cost effective remedy, however may not be a long term solution. There may be an option for the BOR to engage their Engineers to study the site and provide options for protecting the beach area. If so, this should be pursued as soon as possible in order for a long term solution to be implemented (See photo #2).*

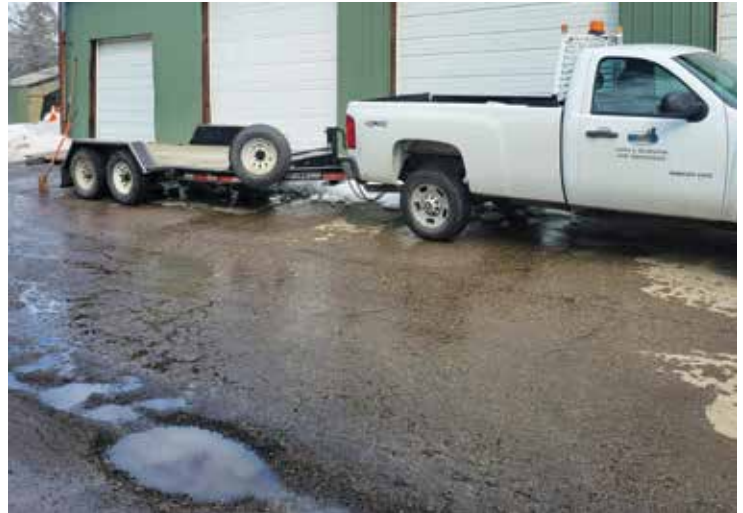
Photo # 1

- *The two storage sheds are quite old and un-insulated. During extreme weather conditions, this creates an unsafe workspace for the staff (see photo #1). It is recommended that these sheds be demolished, and a single larger shed be constructed in their place. In addition, a new facility should be designed with a lean to awning to accommodate outdoor storage of City equipment.*

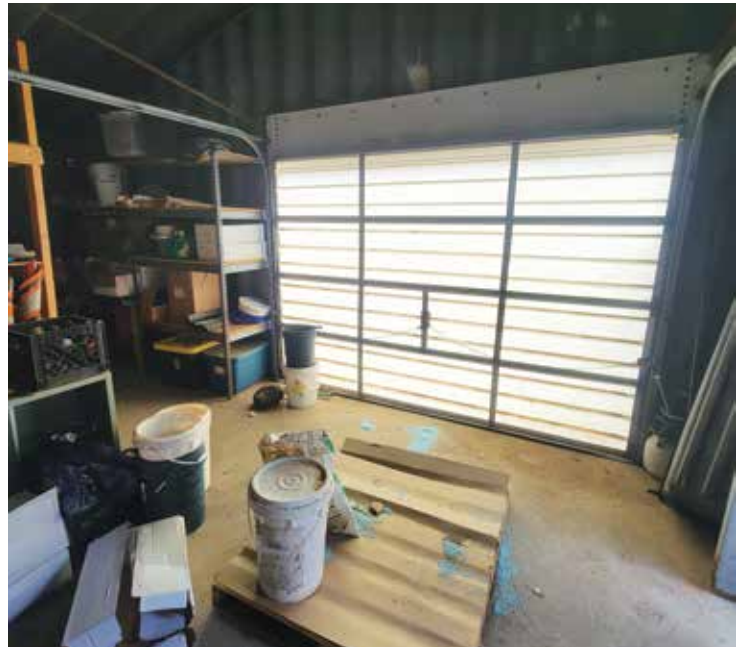
Fuel Island

Although the new shop has provided greatly needed space for the parks operations, the division is experiencing a shortage of office space and secure storage for large pieces of equipment. Parking is limited during the peak season. The location of the fuel island is not ideal and discussions have been held regarding its relocation. The unfinished storage sheds are in very poor condition and in need of renovation or replacement.

- It is recommended that staff complete a mini master plan of this site to determine the best options for:
 1. New storage shed,
 2. Possible relocation of fuel island,
